Transmission Facility Outages During the Northeast Snowstorm of October 29–30, 2011

Causes and Recommendations

Federal Energy Regulatory Commission *and* the North American Electric Reliability Corporation

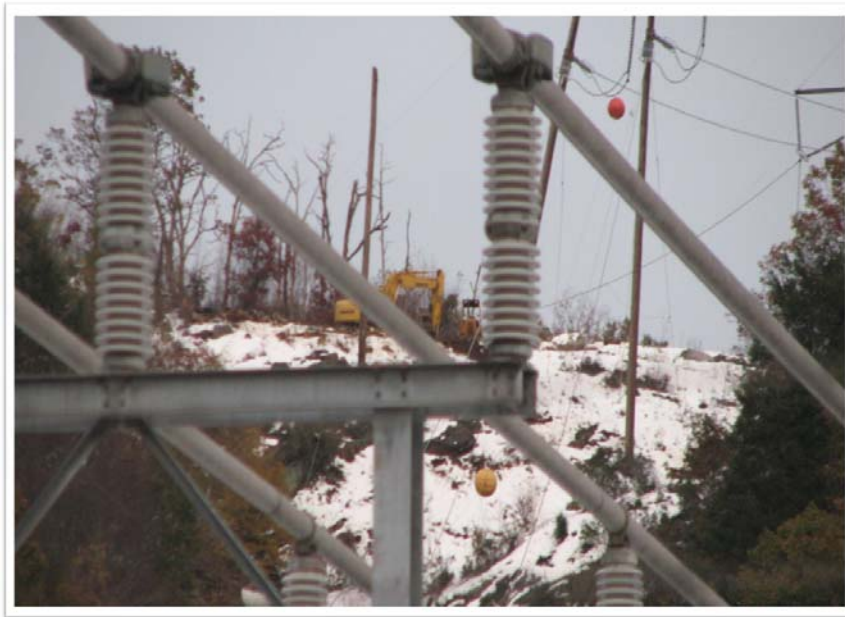
Figure 15: Structure Failure on a 345kV Line in Connecticut

Extreme weather conditions caused several transmission facilities to break, resulting in transmission line outages. Temperatures during the snowstorm hovered around 32 degrees, which is conducive to the accumulation of ice and snow on transmission lines. The weight of the accumulated ice and snow on conductors, and, in one case, high wind conditions, caused a number of structures — including static wires,⁶⁶ conductors, insulators,⁶⁷ and cross-arms⁶⁸ — to break, resulting in six transmission line outages and approximately 32,000 customer outages. Although a number of the transmission structures that failed were several decades (or even more than fifty years) old, it does not appear, based on data obtained during the inquiry, that these structures were in need of repair before the storm. Data reviewed by staff also indicates that the affected structures had been maintained according to utility plans, which staff finds are consistent with typical utility practice.

The 345 kV line shown in the photograph above was forced out of service when the weight of ice and heavy, wet snow on conductors damaged a structure and broke a conductor, static wire, cross-arms, guy-wires,⁶⁹ and insulators. This photograph shows (in the background) a wood pole where cross-arms and guy-wires have broken and the conductor has fallen to the ground.
