Transmission Facility Outages During the Northeast Snowstorm of October 29–30, 2011

Causes and Recommendations

Federal Energy Regulatory Commission *and* the North American Electric Reliability Corporation

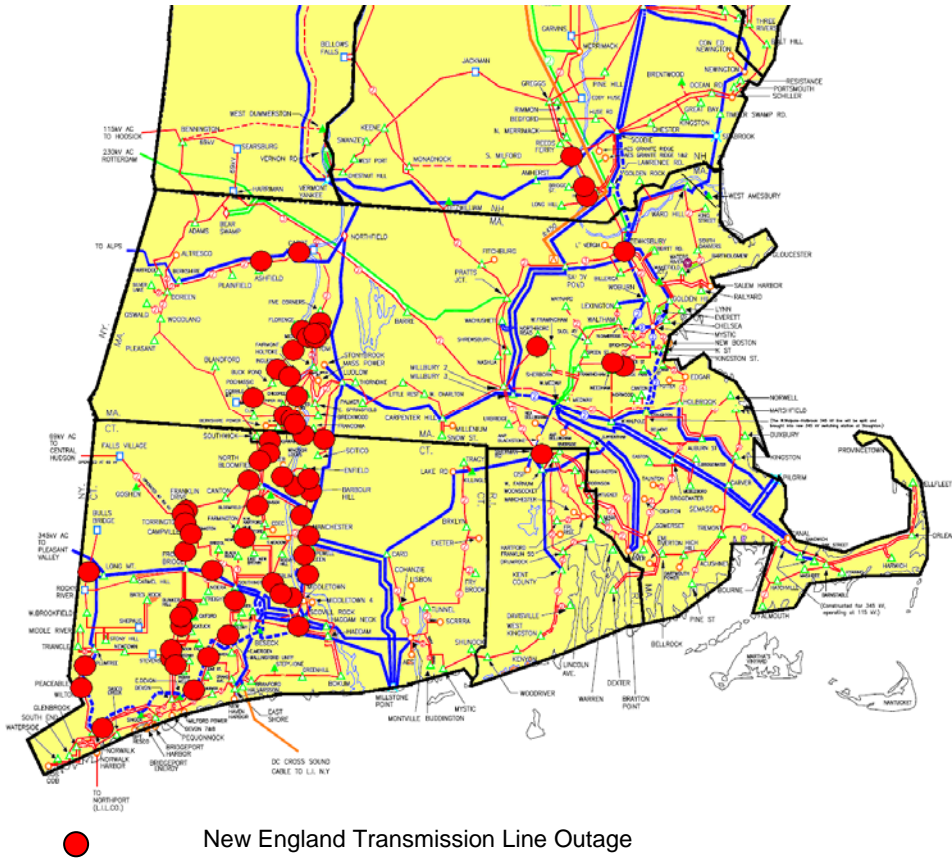
As the following map shows, transmission line outages were concentrated in the Connecticut River Valley area, through Connecticut and into Massachusetts.

Figure 7: ISO-NE Transmission Line Outages During the October Snowstorm

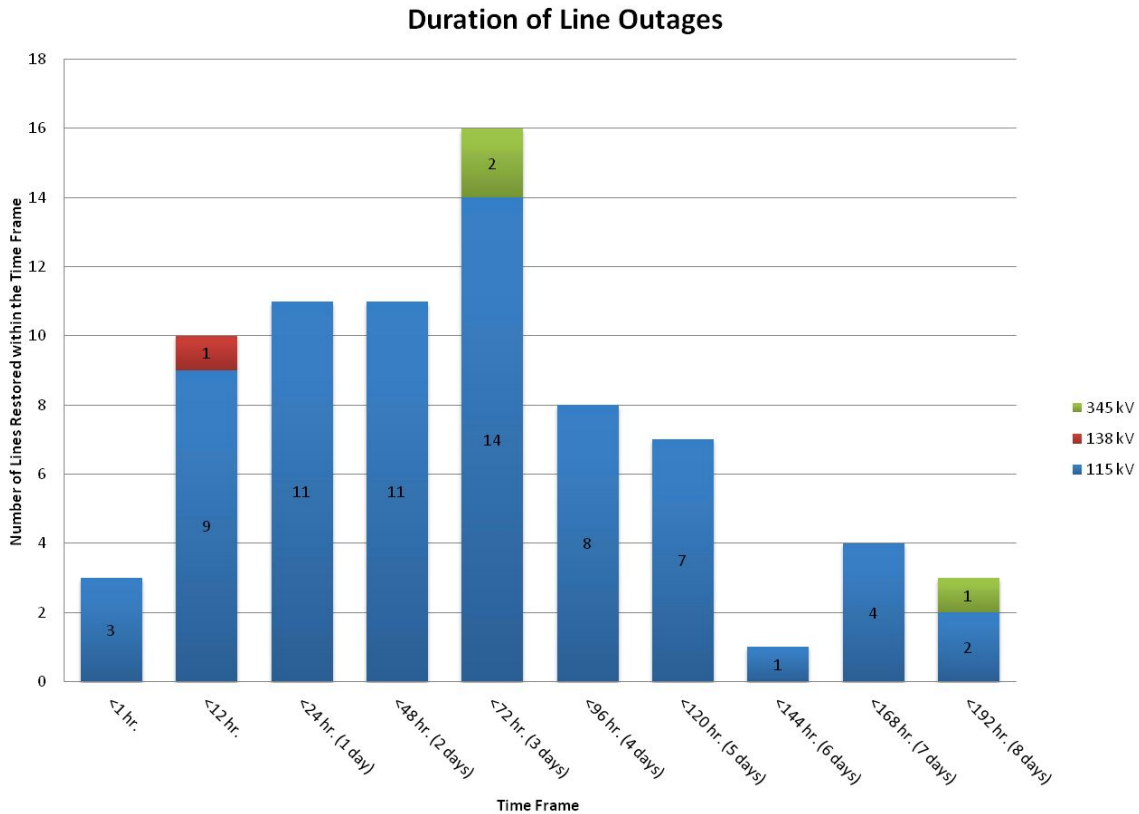
While most transmission facilities were restored relatively quickly, four were out of service for nearly a week, and an additional three remained out of service between seven and eight days. However, none of these seven transmission line outages resulted in customer outages or were, at that time, necessary for BPS stability. The following chart illustrates the duration of transmission line outages.

Figure 10: Duration of Transmission Line Outages
